# Naval Facilities Engineering Command

**NAVFAC MO-102.4**

## **JOINTED CONCRETE AIRFIELDS**

## **Pavement Condition Index (PCI) Field Manual**

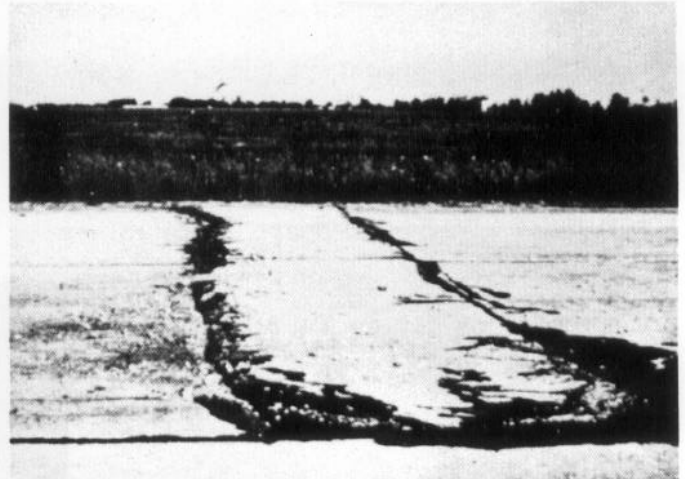
**Figure 81.** Medium severity blow-up

M - Buckling or shattering has not rendered the pavement inoperative, but a significant amount of roughness exists. (Figure 81)

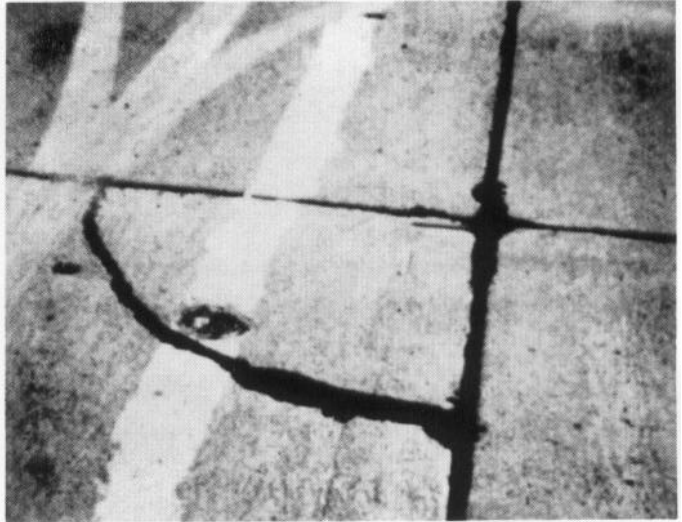
**Figure 84.** Low severity corner break

**L** - Crack has either no spalling or minor spalling (no FOD potential). If non-filled, it has a mean width less than approximately 1/8 inch (3.2 mm); a filled crack can be of any width, but the filler material must be in satisfactory condition. The area between the corner break and the joints is not cracked. (Figures 83 and 84)

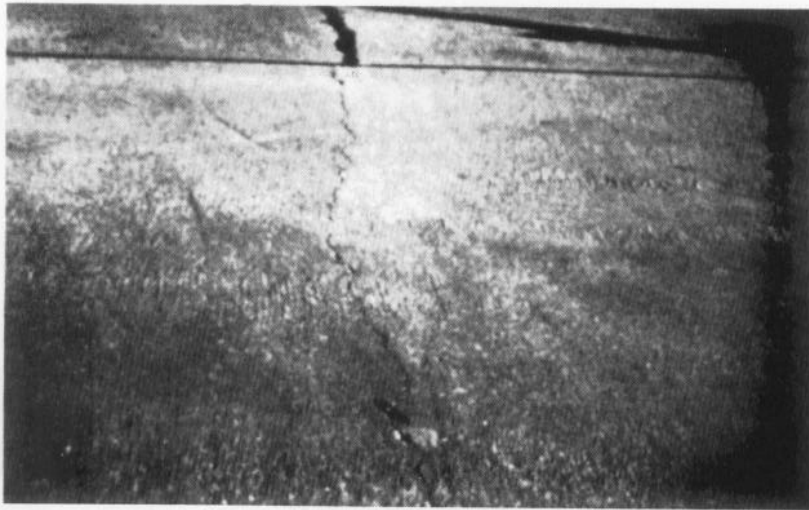
**Figure 88.** Low severity longitudinal crack

**L-** (1) crack has no spalling or minor spalling (no FOD potential). If nonfilled, it is less than 1/8 inch (3.2 mm) wide; a filled crack can be of any width, but its filler material must be in satisfactory condition; or (2) the slab is divided into three pieces by low severity cracks. (Figures 88, 89, and 90)

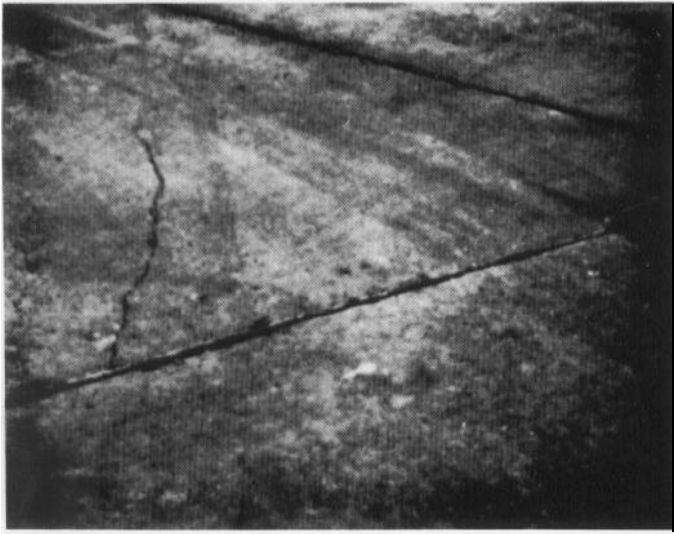
**Figure 90.** Low severity diagonal crack

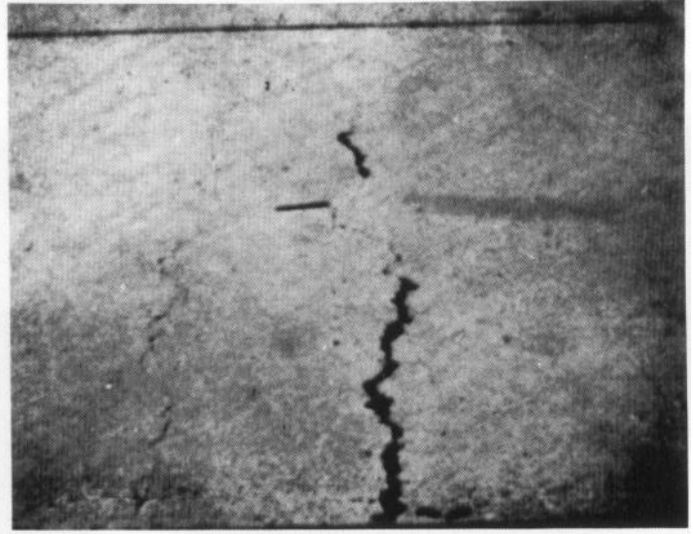
**Figure 91.** Medium severity longitudinal crack

**M** - One of the following conditions exists: (1) a filled or nonfilled crack is moderately spalled (some FOD potential); (2) a nonfilled crack has a mean width between 1/8 inch (3.2mm) and 1 inch (25.4 mm); (3) a filled crack has no spalling or minor spalling, but the filler is in unsatisfactory condition; or (4) the slab is divided into three pieces by two or more cracks, one of which is at least medium severity. (Figures 91, 92, and 93)

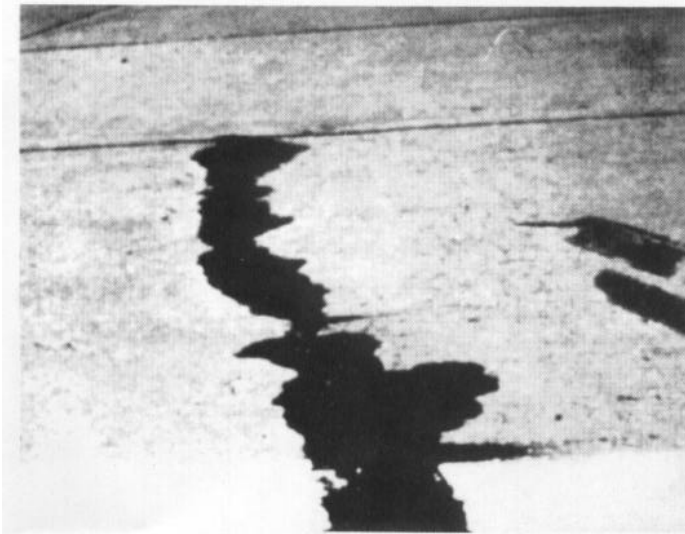
**Figure 92.** Medium severity transverse crack

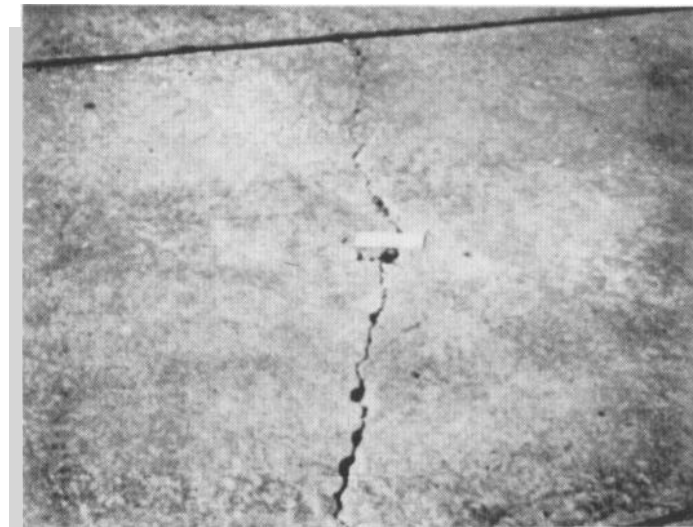
**Figure 93.** Medium severity transverse crack

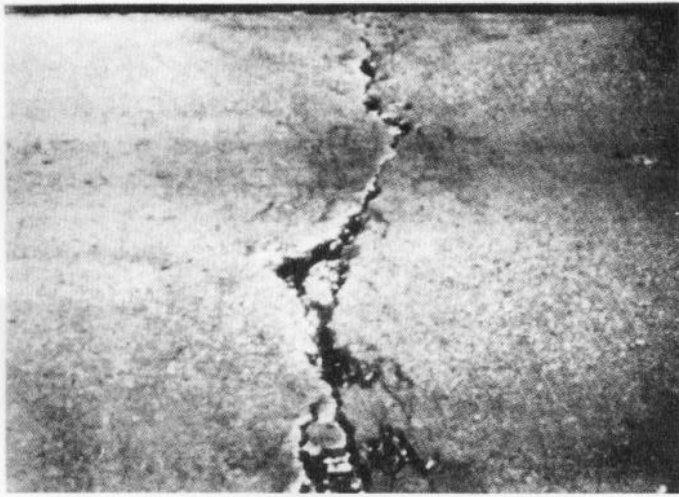
**Figure 94.** High seventy crack

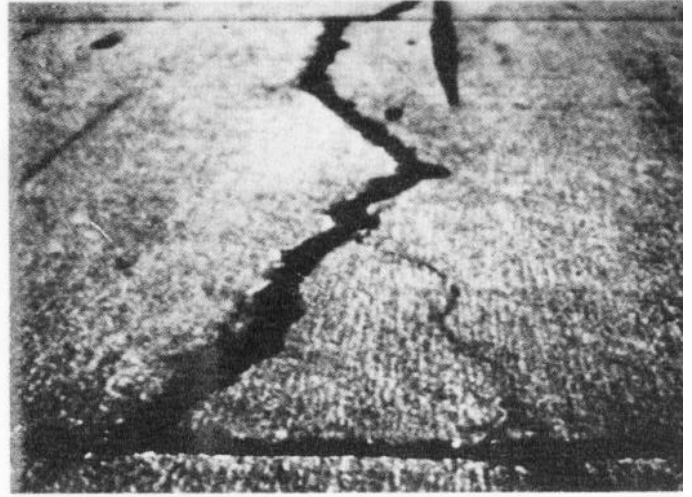
**Figure 95.** High seventy longitudinal cracks

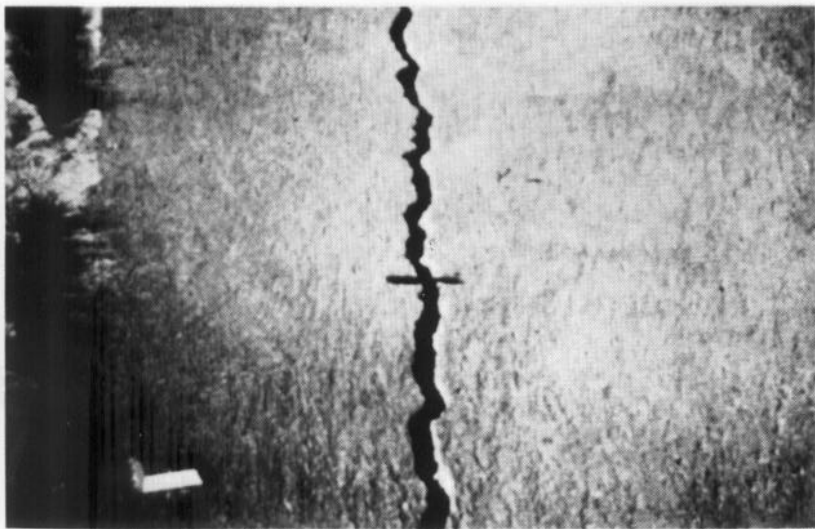
**Figure 96.** High severity crack

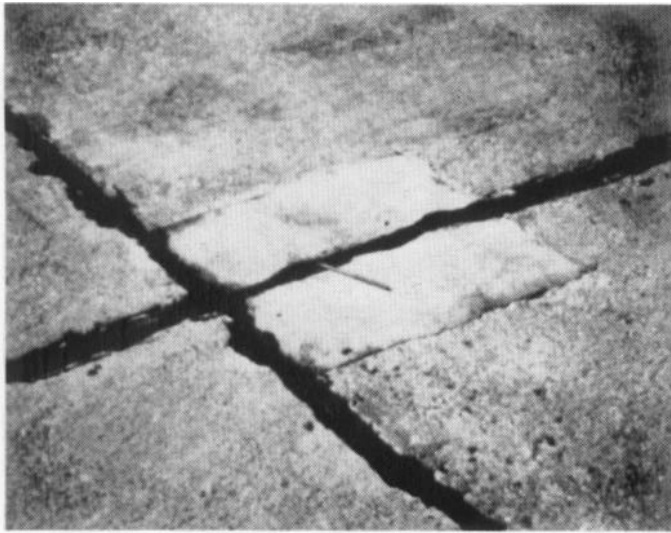
**Figure 107.** Low severity small patch

**Levels:** L - Patch is functioning well with little or no deterioration. (Figures 107 and 108)

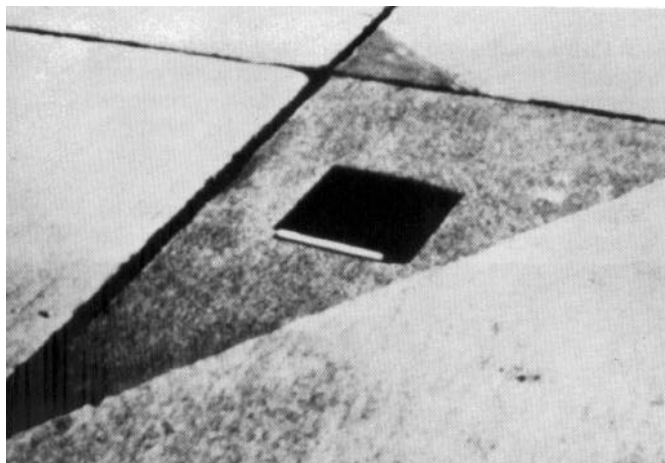
**Figure 112.** Low severity patch

L - Patch is functioning well with very little or no deterioration  
(Figures 112, 113, and 114)

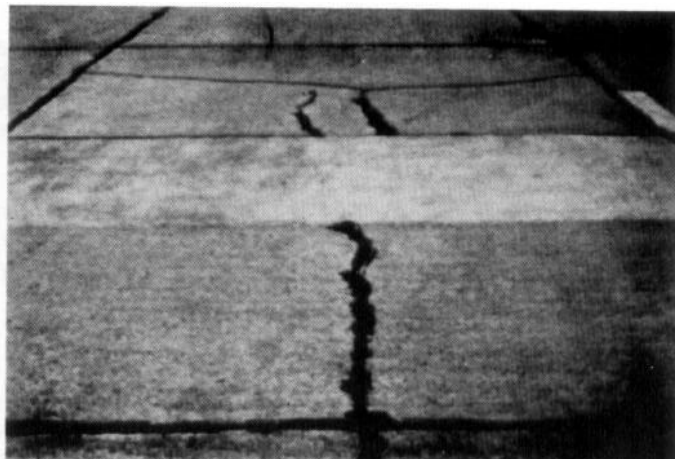
**Figure 113.** Low severity patch

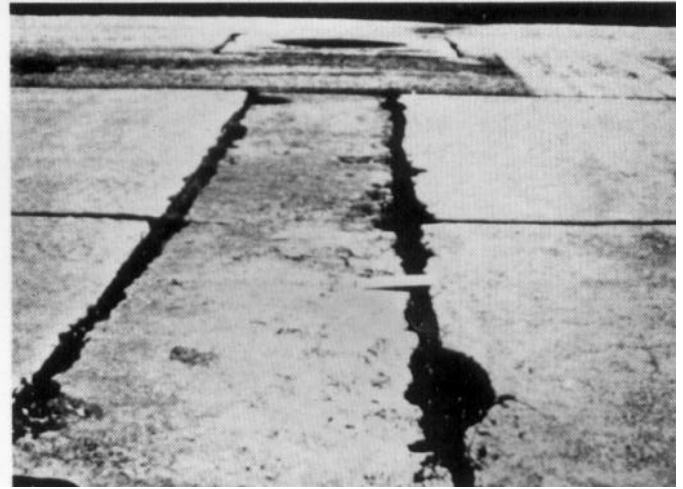
**Figure 115.** Medium severity utility cut

M - Patch has deteriorated and/or moderate spalling can be seen around the edges. Patch material can be dislodged with considerable effort, causing some FOD potential. (Figure 115)

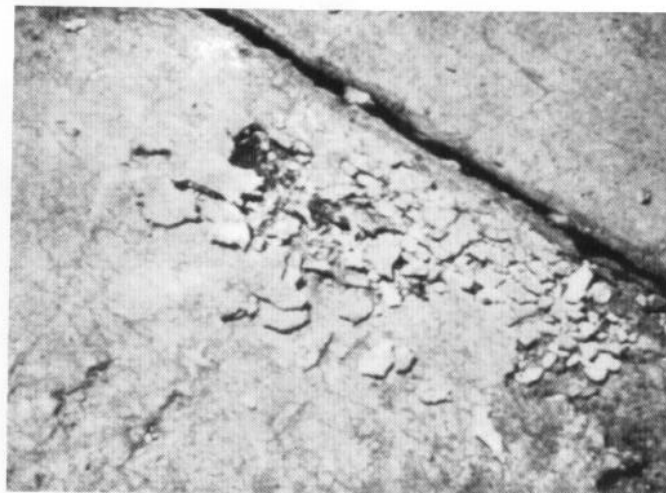
**Figure 125.** Close-up of high severity scaling

H -Slab is severely scaled, causing a high FOD potential. Usually more than 5 percent of the surface is affected. (Figures 124, 125, and 126)

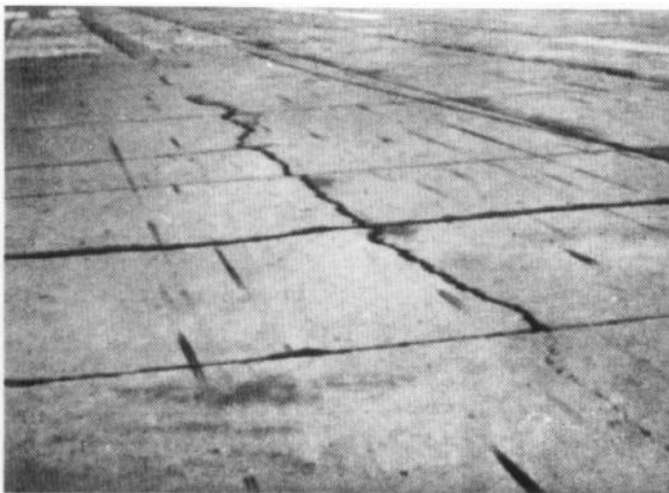
**Figure 132.** Low severity intersecting cracks

L - Slab is broken into four or five pieces with the vast majority of the cracks (over 85 percent) of low severity. (Figures 132 and 133)

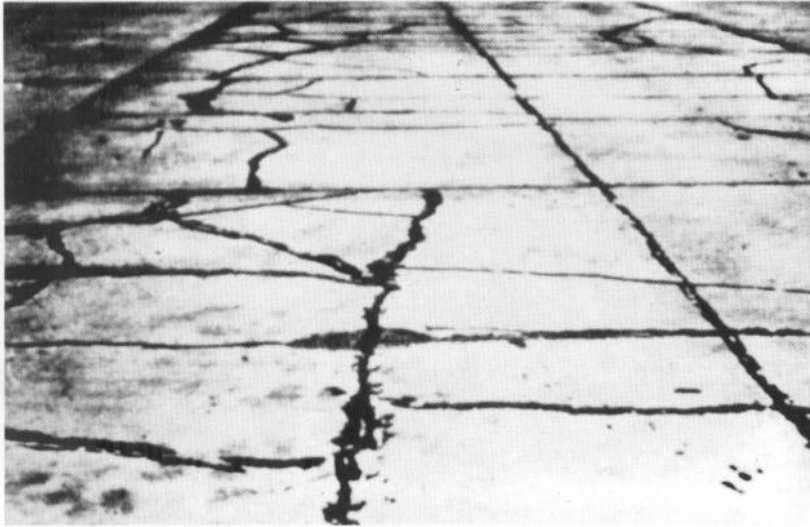
**Figure 136.** Shattered slab

H -At this level of severity the slab is called shattered: (1) slab is broken into four or five pieces with some or all of the cracks of high severity; (2) slab is broken into six or more pieces with over 15 percent of the cracks of medium or high severity. (Figure 136)

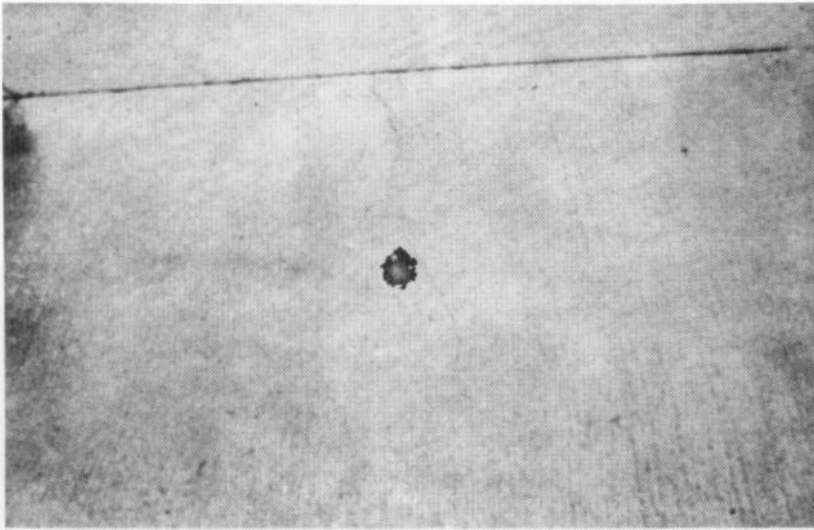
**Figure 139.** Shrinkage cracks

Severity Levels: No degrees of severity are defined. It is sufficient to indicate that shrinkage cracks exist. (Figures 137, 138, and 139)

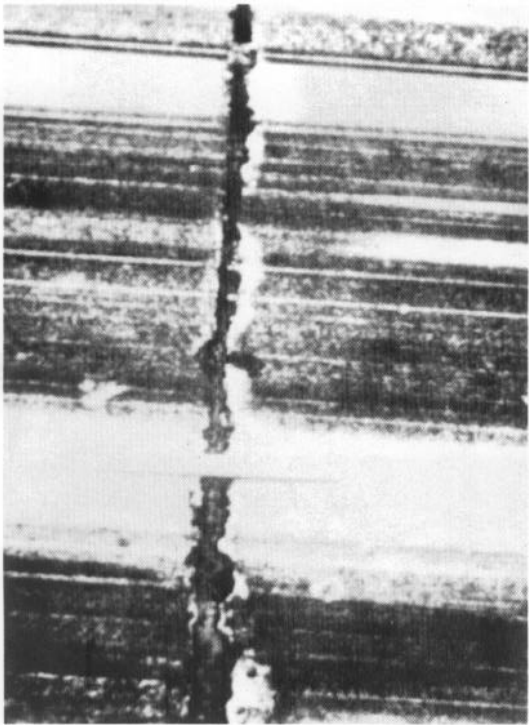
**Figure 140.** Low severity joint spalling (if the frayed area was less than 2 feet long it would not be counted)

L - a. Spall over 2 feet (.6m) long: (1) spall is broken into no more than three pieces defined by low or medium severity cracks; little or no FOD potential exists; or (2) joint is lightly frayed; little or no FOD potential exists. (Figures 140 and 141)

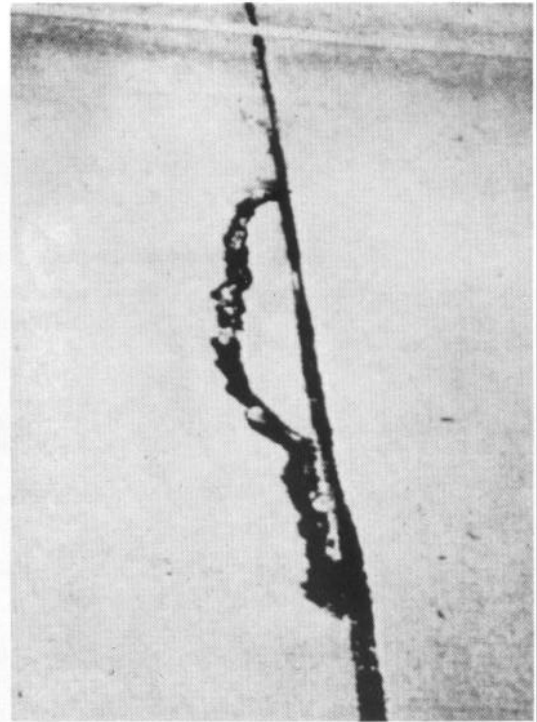
**Figure 141.** Low severity joint spall

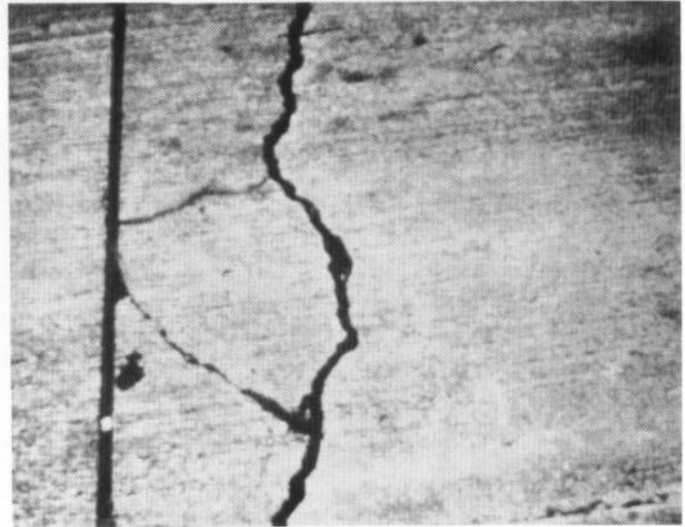
**Figure 143.** Medium severity joint spall

M - a. Spall over 2 feet (.6 m) long: (1) spall is broken into more than three pieces defined by light or medium cracks; (2) spall is broken into no more than three pieces with one or more of the cracks being severe with some FOD potential existing; or (3) joint is moderately frayed, with some FOD potential. (Figure 143)

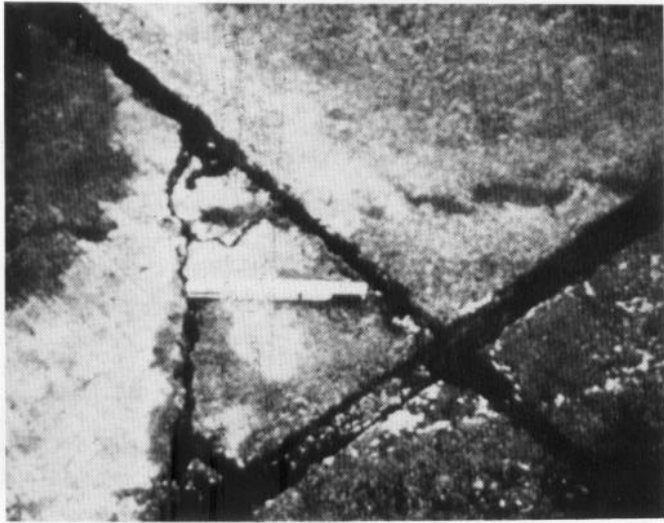
**Figure 149.** Medium severity corner spall

M -One of the following conditions exists: (1) spall is broken into two or more pieces defined by medium severity crack(s), and a few small fragments may be absent or loose; (2) spall is defined by one severe, fragmented crack that may be accompanied by a few hairline cracks; or (3) spall has deteriorated to the point where loose material is causing some FOD potential. (Figures 149 and 150)
